LR-26580

**FLIGHT SERVICE EVALUATION
OF PRD-49/EPOXY COMPOSITE PANELS
IN WIDE-BODIED COMMERCIAL TRANSPORT AIRCRAFT**

**FIRST ANNUAL
FLIGHT SERVICE EVALUATION REPORT**

**Lockheed-California Company
Burbank, California**

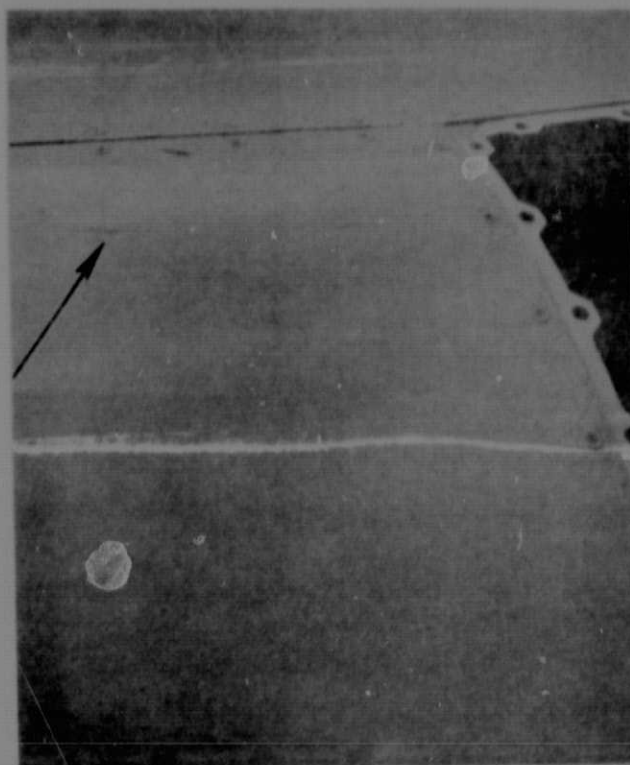
There were some minor indentations on the exterior surface of the panels, but similar damage was also observed on adjacent fiberglass panels. In one instance there was a 2.54 centimeter (one inch) crack in the exterior skin of the left panel as shown in Figure II. Minor repair will be required to cover the hole.

Figure II Crack in Wing-to-Body Fairing

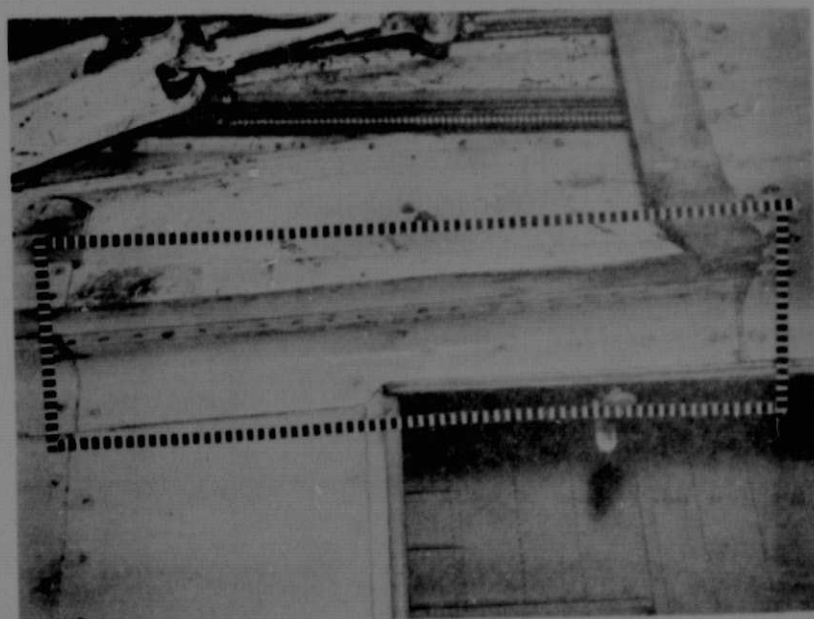
A few attachments were removed from the panels and the fastener holes that were observed were in good condition. Figure III shows the right hand panel installed on the aircraft.

Figure III Wing-Body Fillet Installed on Aircraft

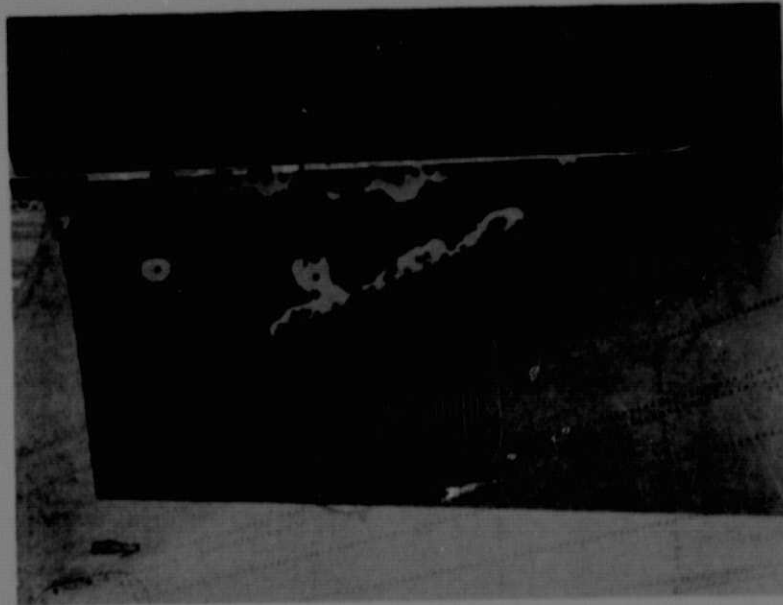
Some paint had been removed from the exterior surface of the right hand panel as shown in Figure IV. Therefore, it was decided to remove the panel for closer examination. The paint topcoat and primer were not adhering to the flame sprayed aluminum surface. A few fiberglass panels also have had paint adhesion problems which have been traced to inadequate release agent removal. Since these panels contained the elevated temperature resistant resin, they had to be cured at a higher temperature which creates some difficulty in getting the flame spray coating to release from the tool. However, this problem has been resolved on subsequent production lots. All loose paint was removed and the panel was repainted prior to re-installation.

Figure IV Center Engine Fairing

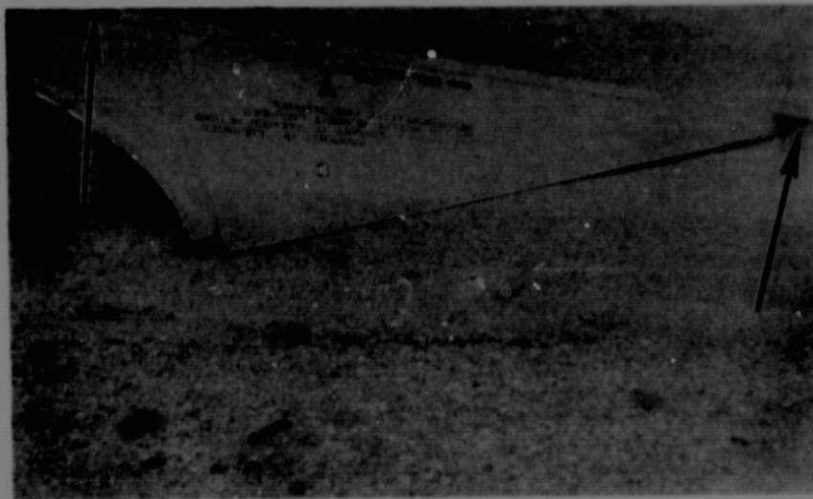
It was also observed that a single ply of fabric had been bonded to both ends of the panel as shown in Figure V. However, there is no record of this rework at either the Lockheed or Air Canada facilities. The repair material used and the time of its application are still unknown.

Figure V Center Engine Fairing with Added Material at Ends

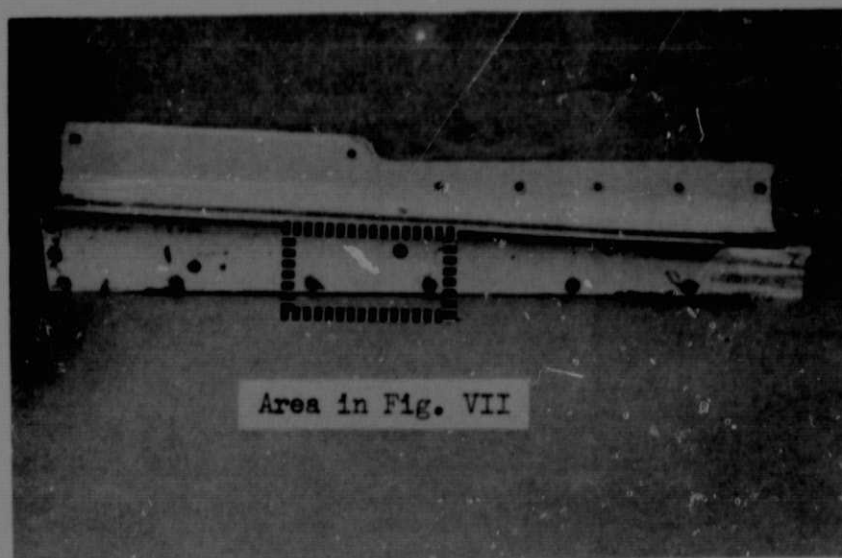
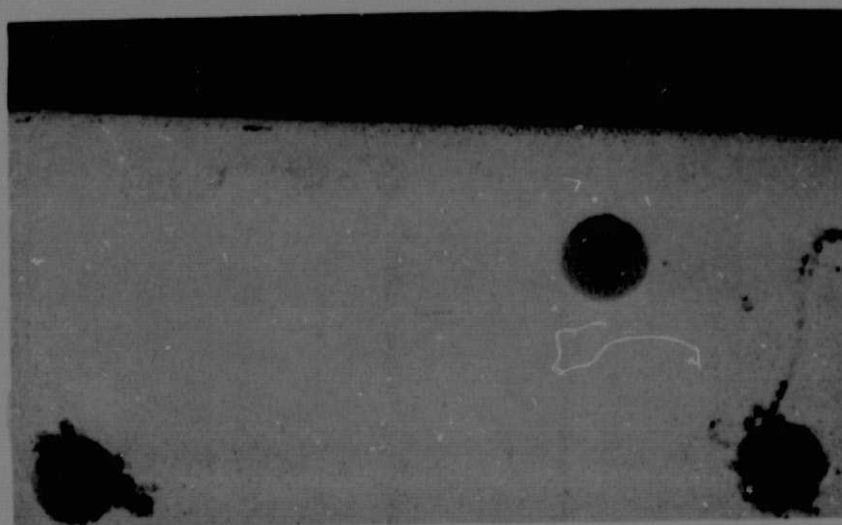
The only damage to the fillets was some elongation of the holes in the right hand panel as shown in Figures VI and VII. These holes will be repaired by sanding down the frayed fibers, solvent cleaning and completely filling the holes with the abovementioned resin system containing five percent glass fibers. Elongation of fastener holes in any of these panel configurations is not peculiar to PRD-49. More severe hole damage has been witnessed on other fiberglass fillet panels.

Figure VI Wing-Body Fillet with Elongated Holes

Figure VII Close-up of Wing-Body Fillet with Elongated Holes

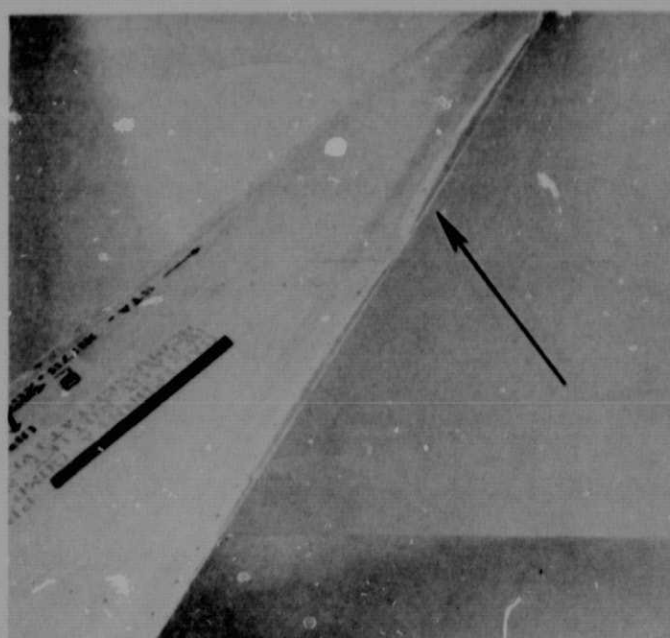
The panel on the right side had one ply of the fabric delaminated along the edge as shown in Figure VIII. On close examination it can be seen that a fillet of sealing compound was still adhering to the edge of the panel along the delaminated areas.

Evidently the adhesion of the sealing compound to the laminate and metal substructure placed a peeling force on the resin matrix causing it to peel back as the panel was removed.

Figure VIII Delamination on Center Engine Fairing

The delaminated ply will be bonded back together with a resin capable of withstanding the 422°K (300°F) service environment.
